# Undetectable Integration of Composite Resin with Natural Tooth Structure

## Accreditation Clinical Case Report, Case Type IV: Class IV Direct Resin Restoration

Ingrida Ivance, DDS

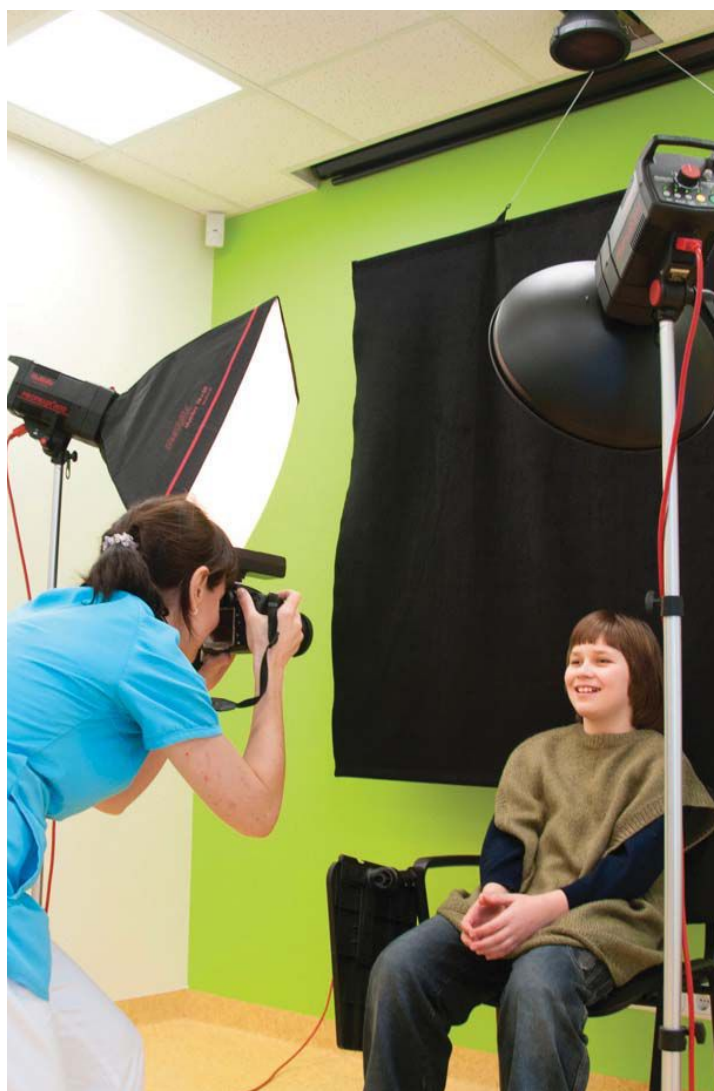
**Figure 2:** Portraiture setup for a dental office.

To perform a high-quality restoration requires more than consultation time, so the patient was invited to have photographs taken for review and study of the AACD Accreditation views.<sup>2</sup> The patient's portrait (**Figs 1a & 1b**) was taken in a portraiture setup for a dental office (**Fig 2**)<sup>3</sup>: two symmetrical strobes with a softbox and a light shaper as main lights, hair light strobe with a reflector, velvet curtain background, Nikon D300 camera (Melville, NY) and Nikkor lens 18-70 mm f/3.5-4.5G ED-IF zoom AFS DX. The patient's smile and teeth (**Figs 3-6**) were photographed using the same camera, Nikkor lens 105 mm F2.8G VR micro, Sigma electronic flash macro EM-140 DG (Sigma Photo; Ronkonkoma, NY); and dental photography accessories such as lip retractors, contrasting device, and occlusal mirrors (**Figs 7a & 7b**).

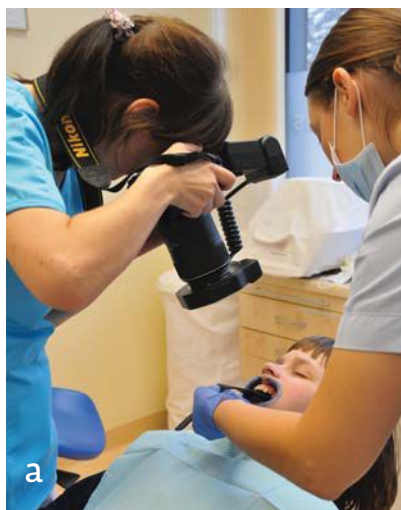
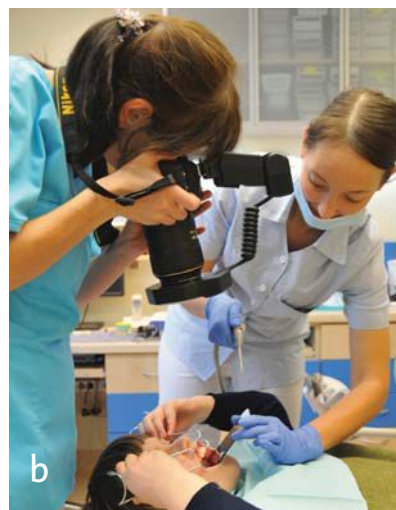
**Figures 7a & 7b:** The teeth were photographed using lip retractors, a contrasting device, and an occlusal mirror.

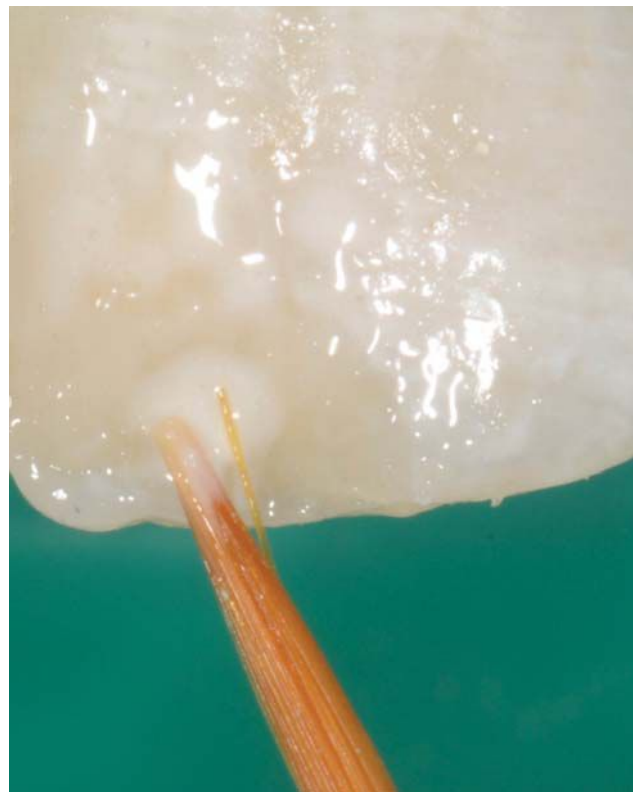
**Figure 8:** Creative Color Opaquer White was used to reproduce the fluorotic enamel structure.

An artist's brush (#1, Cosmedent) was used to apply patches and bands of Creative Color Opaquer White to reproduce the fluorotic enamel structure (Fig 8), as seen on tooth #9. The layer was light-cured for 20 seconds.

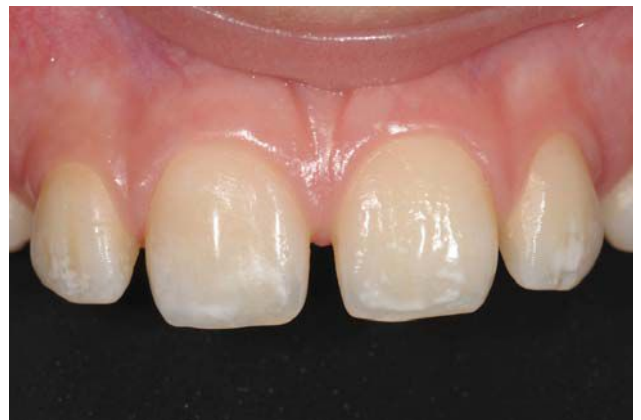
**Figure 9:** In the "after" 1:1 frontal view, the translucency, halo, and whitish, opaque enamel hypoplasia effects create a lifelike mirroring of the adjacent central incisor.

Before the final polishing, the restoration was covered with a layer of "air-block" water-soluble glycerin (Glycerin-gel, Ivoclar Vivadent). Final polymerization was carried out with 20-second cycles on the palatal and facial surfaces to obtain the maximum monomer conversion in the uppermost layer of composite material, normally inhibited by oxygen.<sup>12</sup> A FlexiBuff disc with Enamelize paste (both Cosmedent) was used to obtain the final gloss (Fig 9).

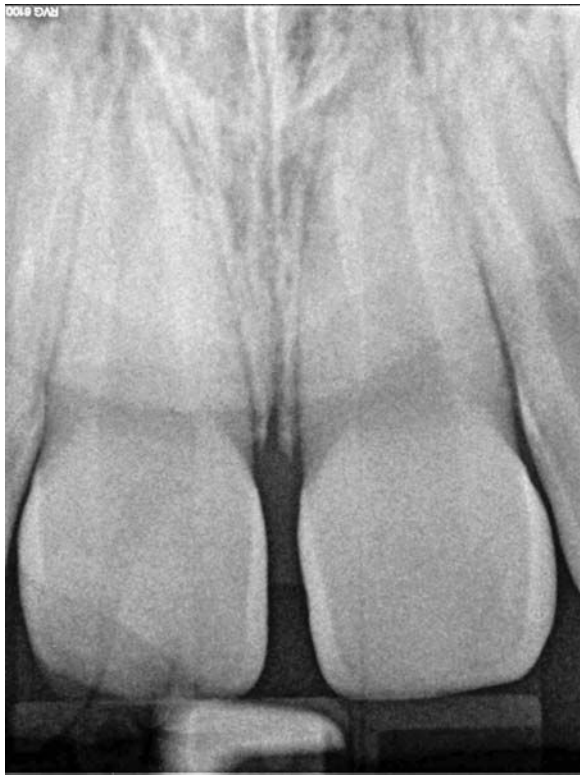
**Figure 11:** A periapical radiograph reveals no root fracture and satisfactory composite adaptation.

The patient was given home care instructions and scheduled to return three days later for a final check of function and esthetics, and to complete photographic and radiographic documentation (Figs 10a-10d & 11). He was invited for post-treatment photography six months later (Figs 12a-12c).

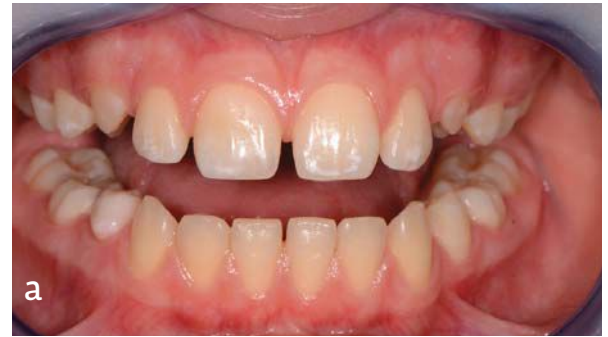
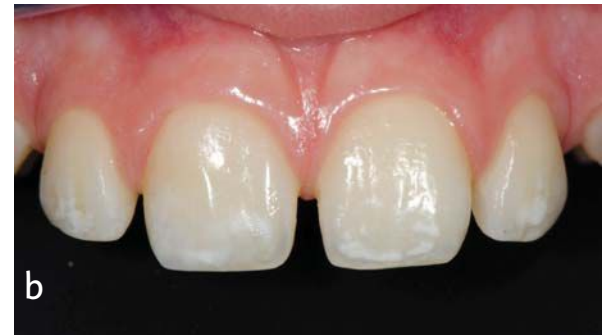
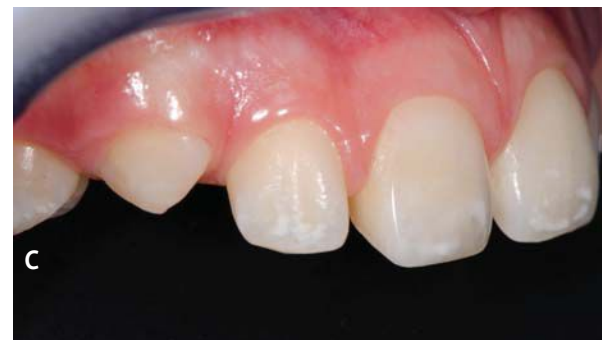
**Figures 12a-12c:** Six-month post-treatment clinical images. Note healthy gingival tissue and good marginal integration.

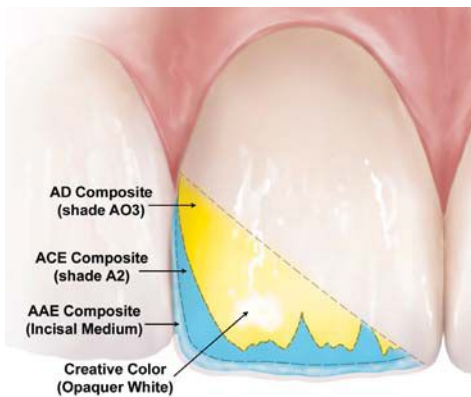
**Figure 1:** The color map details the layering process of the composite resin.

Dr. Ivance did an excellent job with this case, handling the composite resin and blending the restoration into the natural tooth structure. The color selection was well done. The milky-white incisal halo and incisal translucency mimicked the contralateral tooth. The white opaque effect was just slightly overdone, but it was very close (and it is not such an easy thing to accomplish) (Fig 1).
